NATIONAL DAM INSPECTION PROGRAM ULBRICH RESERVOIR DAM
(CT 00038) CONNECTICUT (U) CORPS OF ENGINEERS WALTHAM MA
NEW ENGLAND DIV APR 81

NATIONAL DAM INSPECTION PROGRAM
PHASE I INSPECTION REPORT
ULBRICH RESERVOIR DAM - CT 00038

ULBRICH RESERVOIR DAM (CT00038)

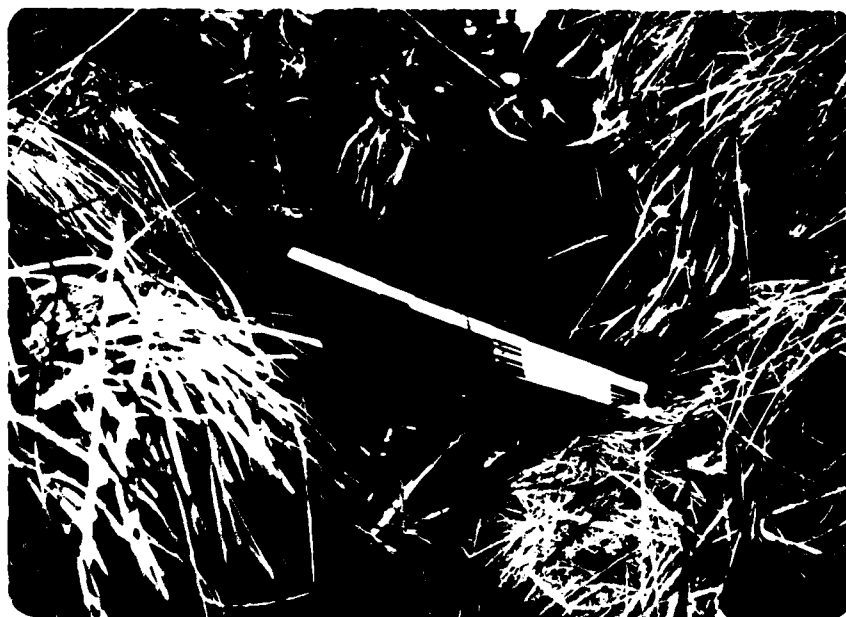
No flow was observed from the 10-inch toe drains, which extend from Sta 16+45 to Sta 20+45 and from Sta 7+45 to Sta 11+45 (Photos Nos. 4, 5, and 12), and no flowing seepage was observed on the downstream slope or toe of the dam. At the time of inspection the reservoir elevation was 5 feet below the spillway crest, 2 feet above the toe drain elevation between Sta 16+45 and Sta 20+45, and about 8 feet above the toe drain elevation between Sta 7+45 and Sta 11+45.

4. 10-inch-diameter concrete pipe in toe drain outlet on left side of spillway discharge channel.

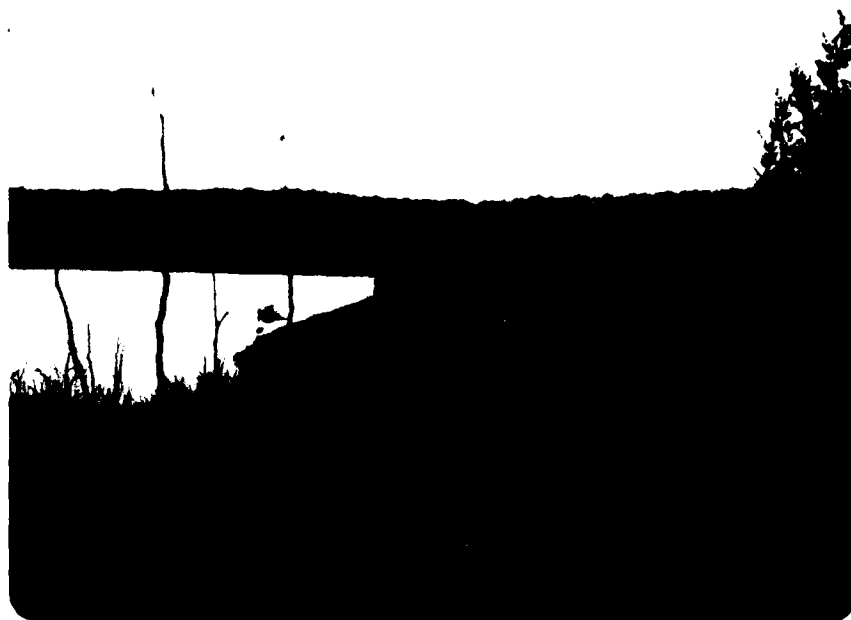
The upstream slope of the dam contains riprap protection extending to an elevation about four feet below the crest. Low brush and occasional small trees are growing between stones in the upper 5 to 10 feet of the riprap left of the spillway (Photo No. 16) and in the upper 10 to 15 feet of the riprap right of the spillway (Photo No. 6). Low brush and small trees were also observed between stones in riprap protection on the left abutment (foreground, Photo No. 16). The riprap stones are generally 1 to 3 feet in size and in satisfactory condition. The upstream slope above the riprap is grass-covered with numerous small trees (Photo No. 15).

6. View of grass and brush growing in riprap on upstream slope right of spillway at Sta 18 + 95.

4. Repair cracking and spalling of spillway apron.
5. Within one year, remove trees, brush and root systems from the crest, slopes, and within 20 feet of the downstream toe of the dam and backfill with appropriate compacted soil.

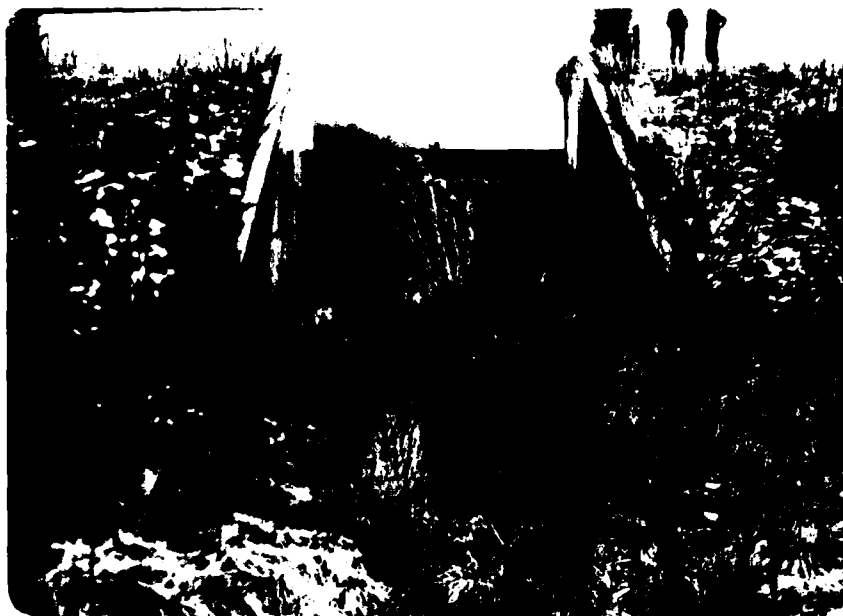
The spillway consists of a concrete weir and training walls with steel flashboards, as shown in Photo No. 9. A concrete apron extends about 30 feet downstream from the weir and is in good condition with the exception of two minor cracks and some spalling. Three vertical hairline cracks extending beneath the water surface were observed on the upstream right training wall. Portions of the downstream training walls have been resurfaced with a slush coat of cement. A crack was observed through the spillway at Sta 16+87. This has been repaired and no leakage was observed through this crack. Slight lateral deflection was observed on the upstream left training wall. There were no indications of seepage adjacent to or through the downstream training walls.

9. Spillway and discharge channel from bridge over discharge channel.
